RESEARCH MEMORANDUM

VIBRATION SURVEY OF BLADES IN 10-STAGE AXIAL-FLOW COMPRESSOR

III - PRELIMINARY ENGINE INVESTIGATION

NATIONAL ADVISORY COMMITTEE
FOR AERONAUTICS

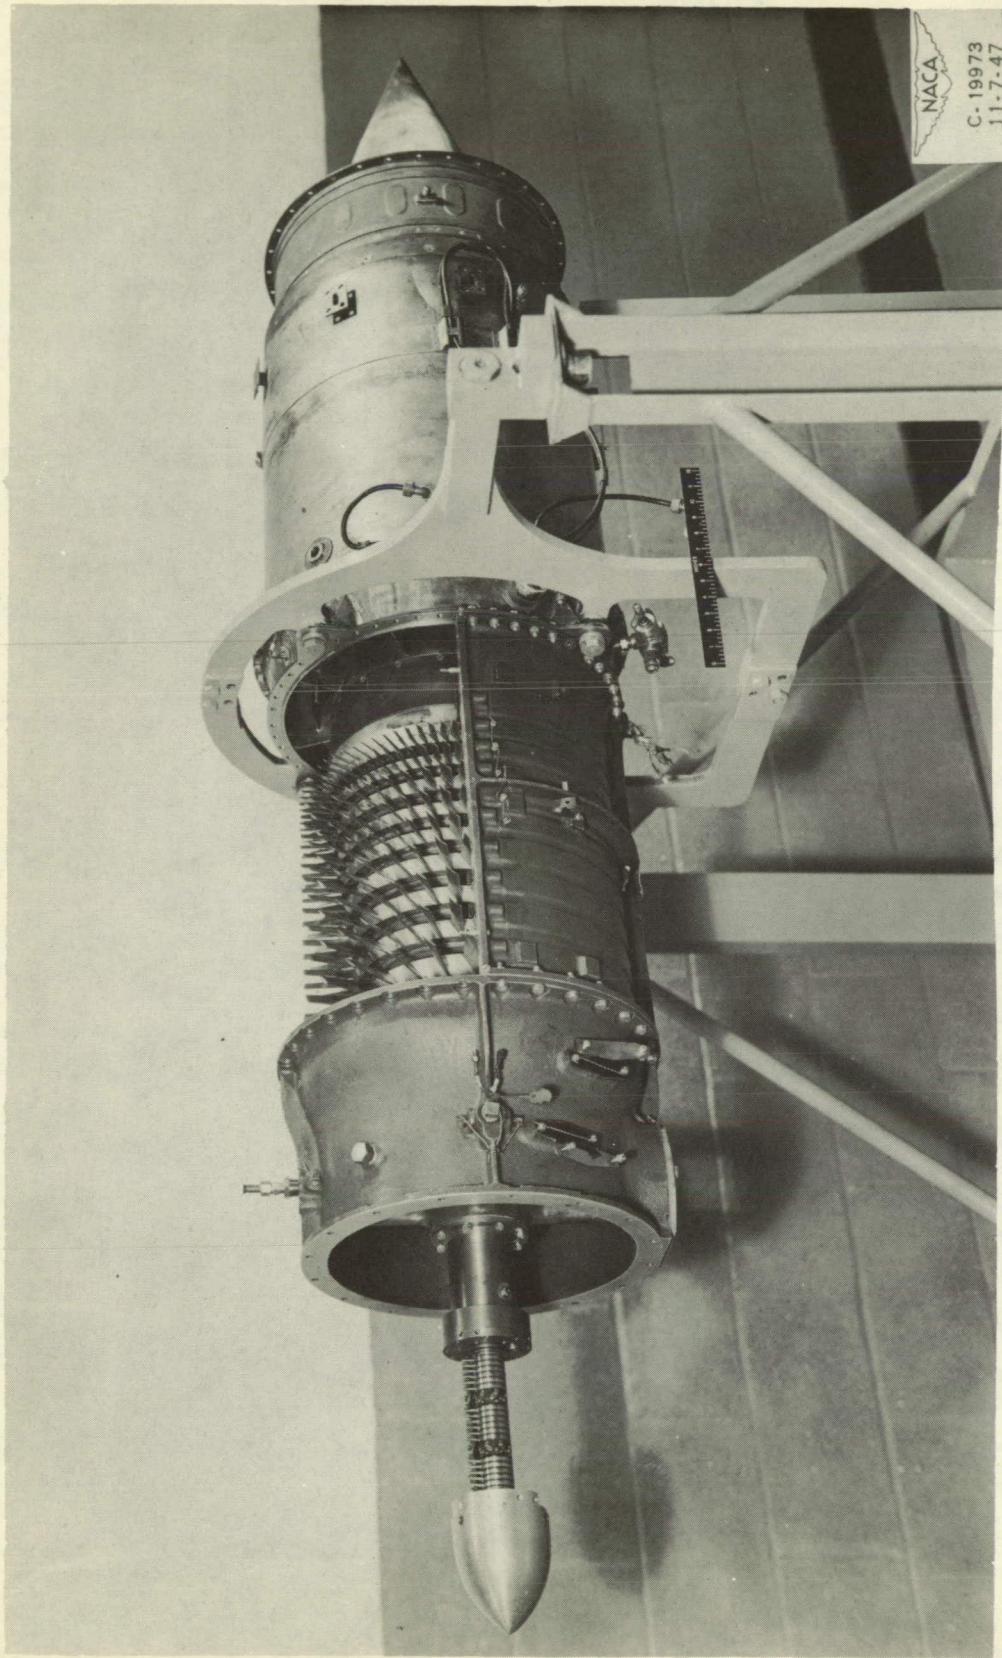
The rebladed compressor was then assembled in a late production jet engine (fig. 1) and mounted on a sea-level-type test stand. The inlet guide vanes furnished with this engine transferred part of the compression load from the rear stages, in which failures had originated, to the front stages. A variable-area clamshell tail cone was substituted for the original jet assembly in an attempt to make it possible to vary the back pressure and consequently the pressure ratio of the compressor.

Figure 1. - Ten-stage axial-flow compressor installed in jet engine.

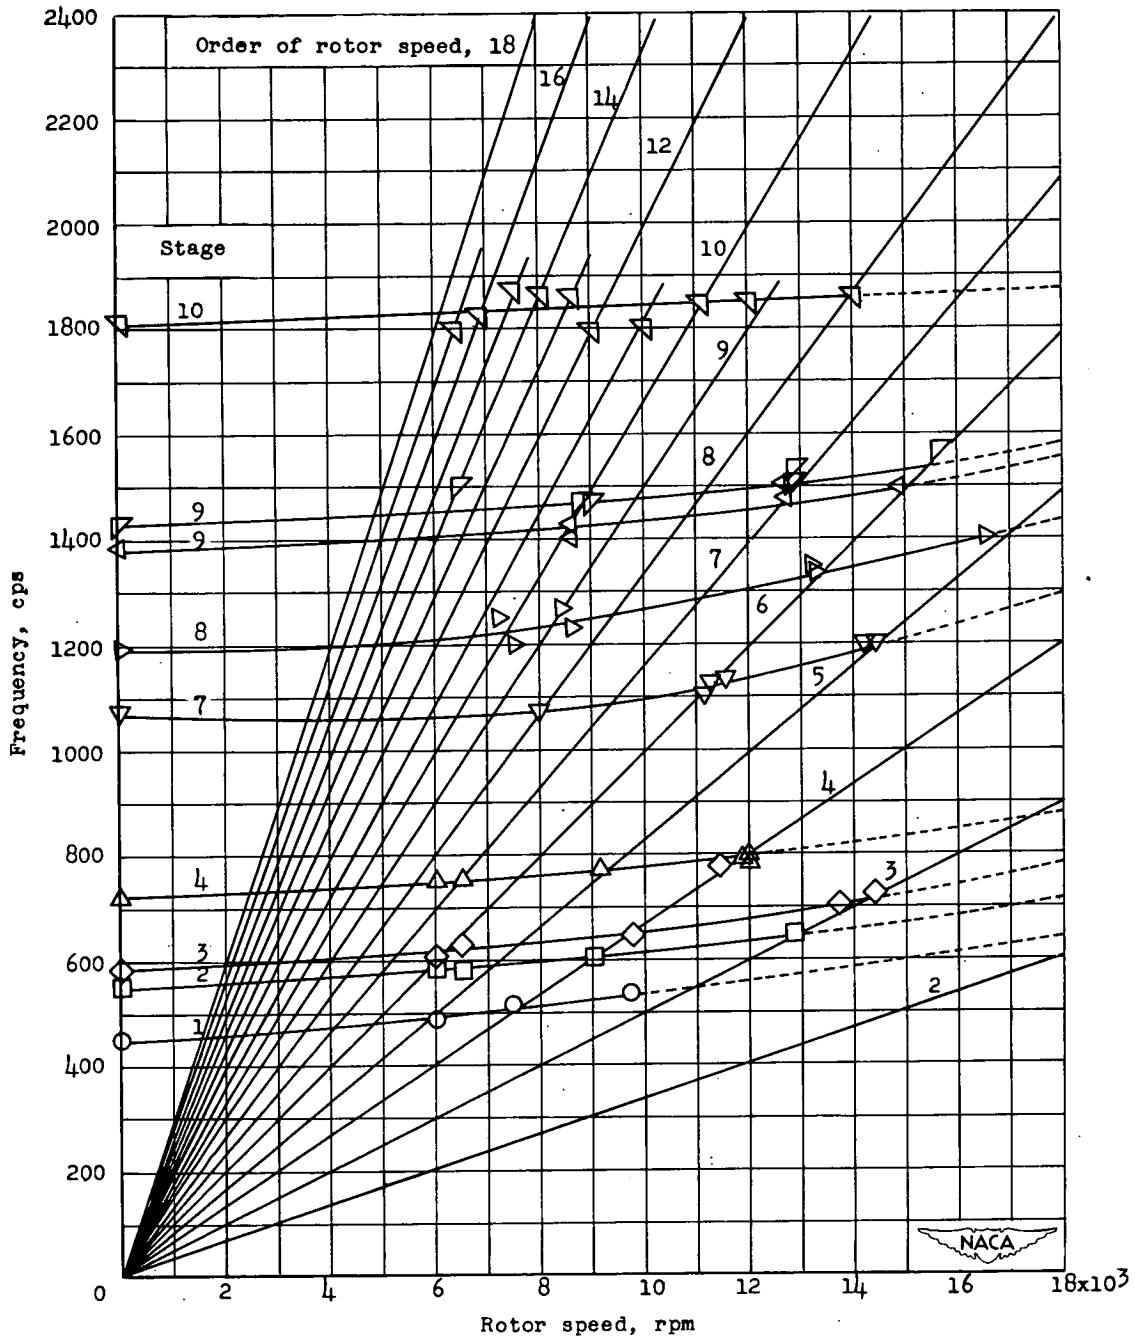
A critical-speed diagram (measured vibratory frequency plotted against rotor speed) showing the orders of vibration encountered is presented in figure 2. Excitation forces from the third to the seventeenth order apparently are present within the compressor and vibrations caused by the orders are exact multiples of rotor speed. A comparison of calculated and measured effect of centrifugal force on blade natural frequency similar to figure 6 of reference 1 is shown in figure 3. Order of excitation is plotted against measured vibratory stress in figure 4. For all stages, the lower the order of vibration the higher the stress and all stages show the same general slope. All the vibratory stresses plotted are produced by first bending-mode vibrations of the cantilever compressor blades. Each stage has an exception to the general trend; some orders are predominant, others are absent. For example, in the tenth stage (fig. 4(c)), the seventeenth order results in the highest stress whereas the eighth, ninth, and twelfth lie below the trend. The source of the high stress at the seventeenth order as well as the source of the other exceptions was undetermined.

Figure 2. - Critical-speed diagram showing measured first bending-mode frequencies for various stages.

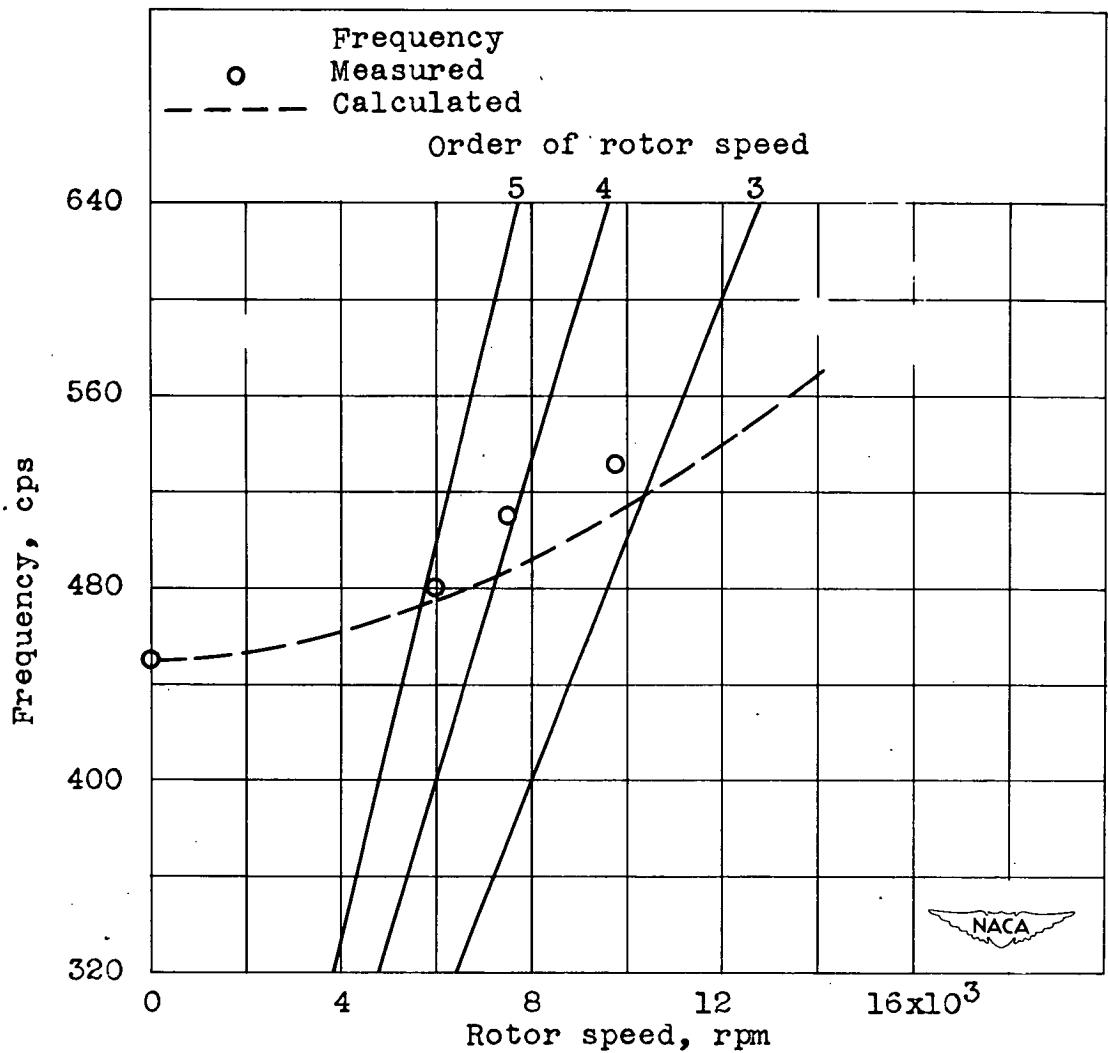
(a) First stage.

Figure 3. - Critical-speed diagram showing measured and calculated first bending-mode frequencies.

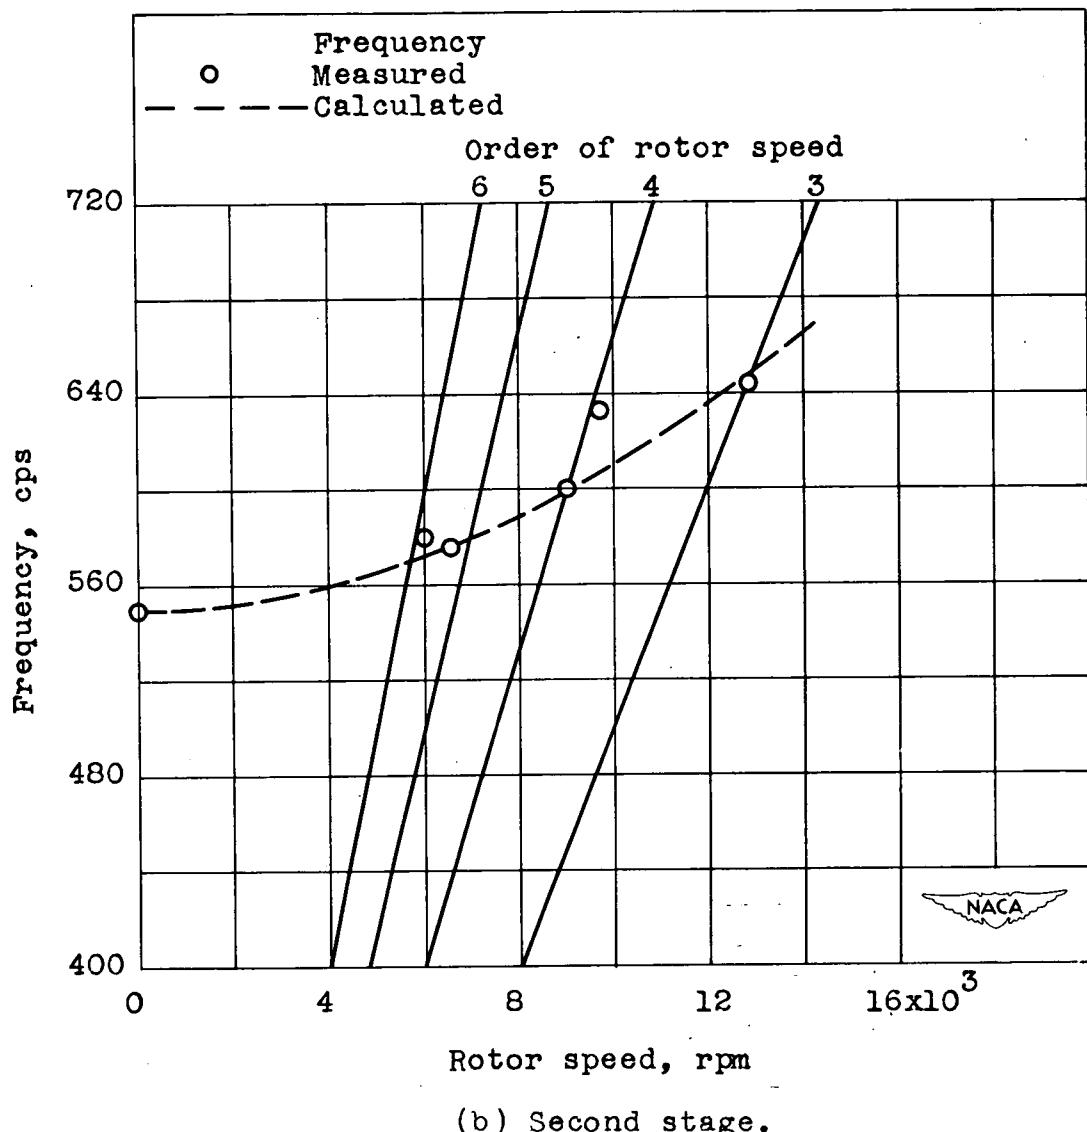
Figure 3. - Continued. Critical-speed diagram showing measured and calculated first bending-mode frequencies.

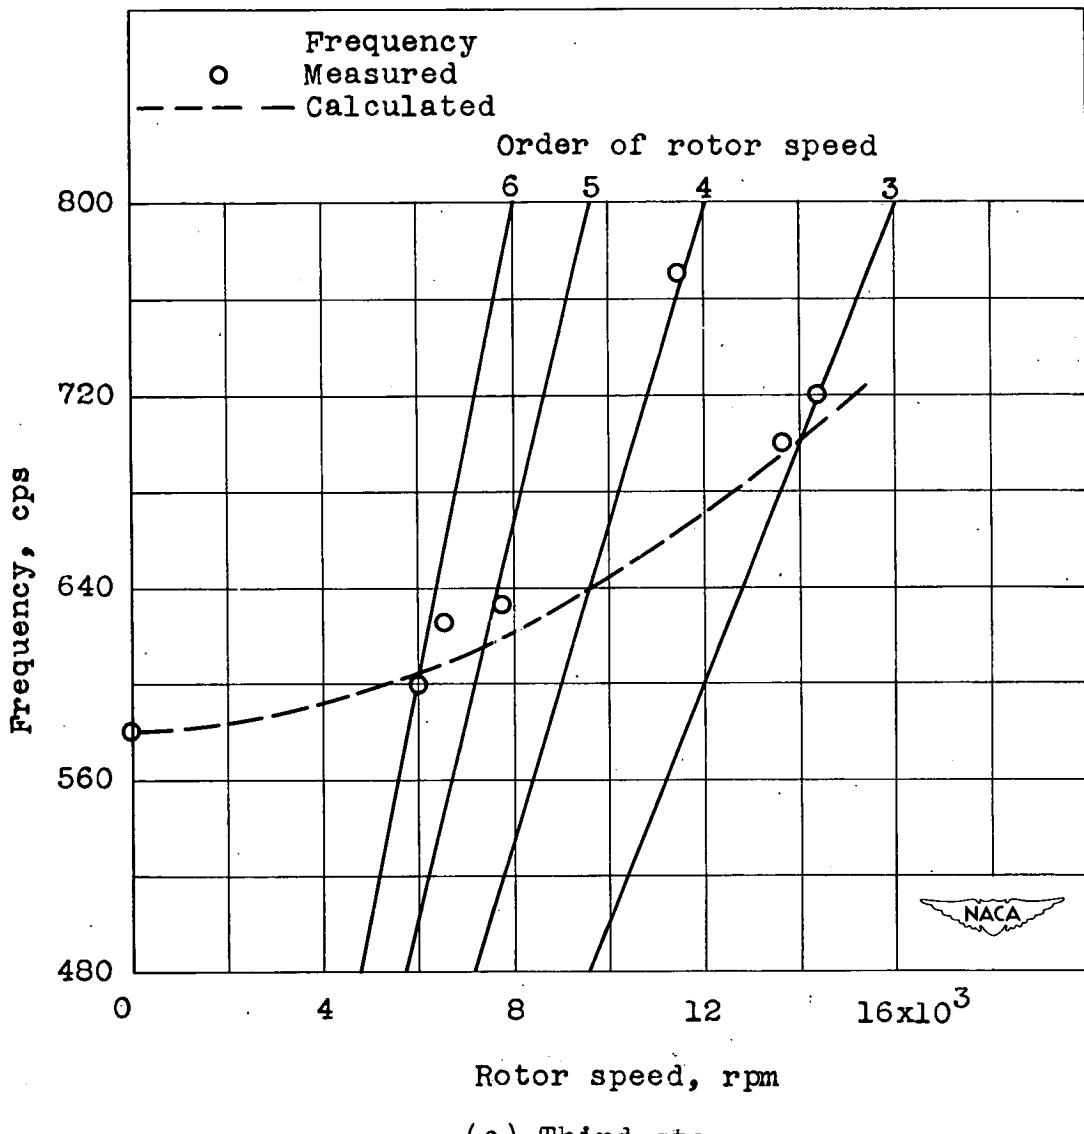
Figure 3. - Continued. Critical-speed diagram showing measured and calculated first bending-mode frequencies.

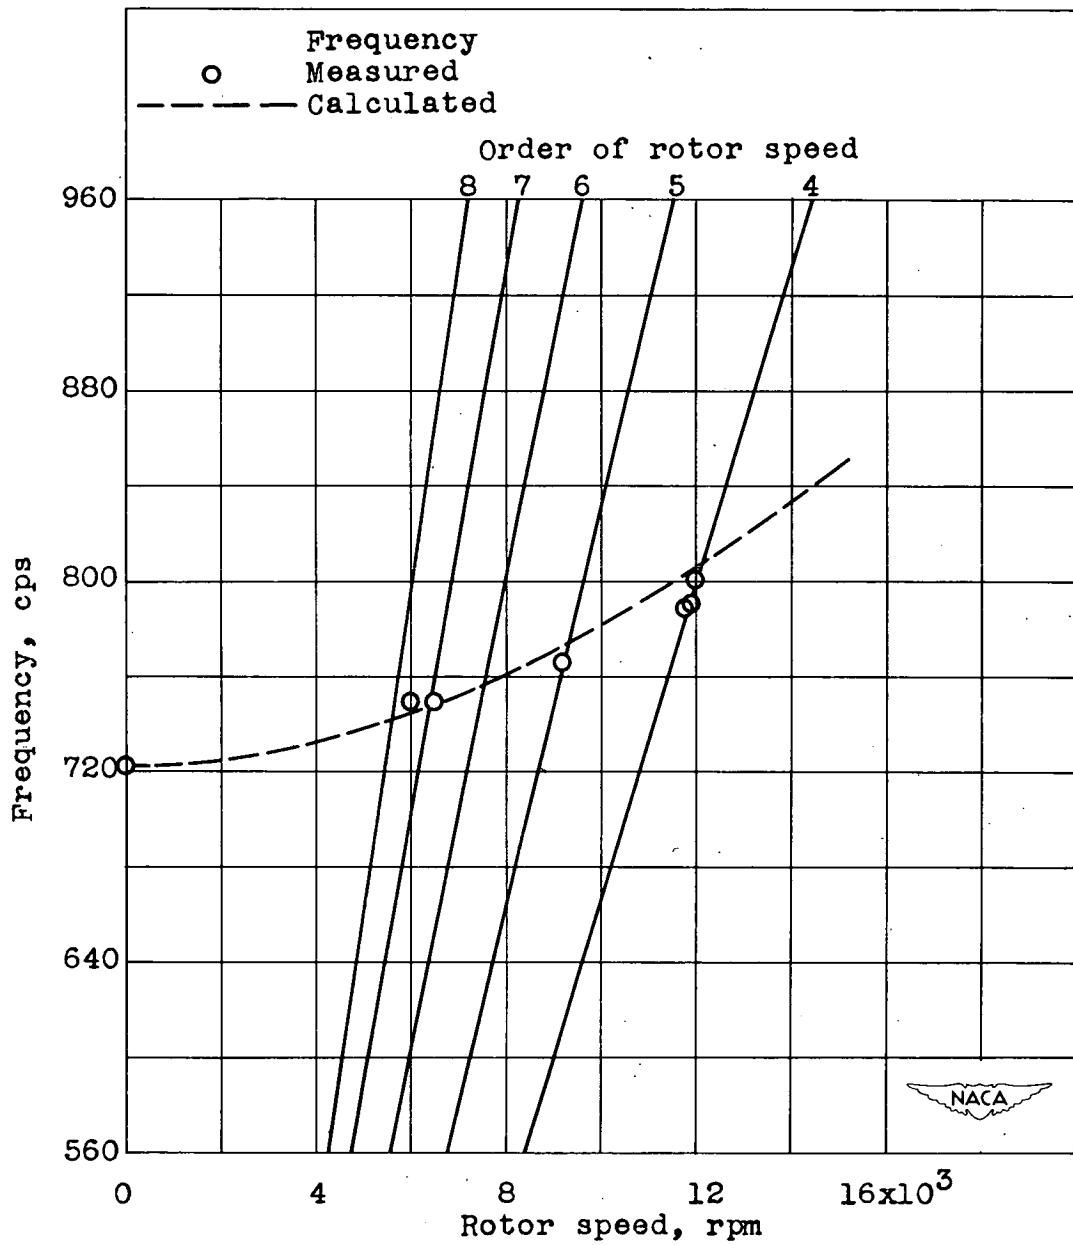
(d) Fourth stage.

Figure 3. - Continued. Critical-speed diagram showing measured and calculated first bending-mode frequencies.

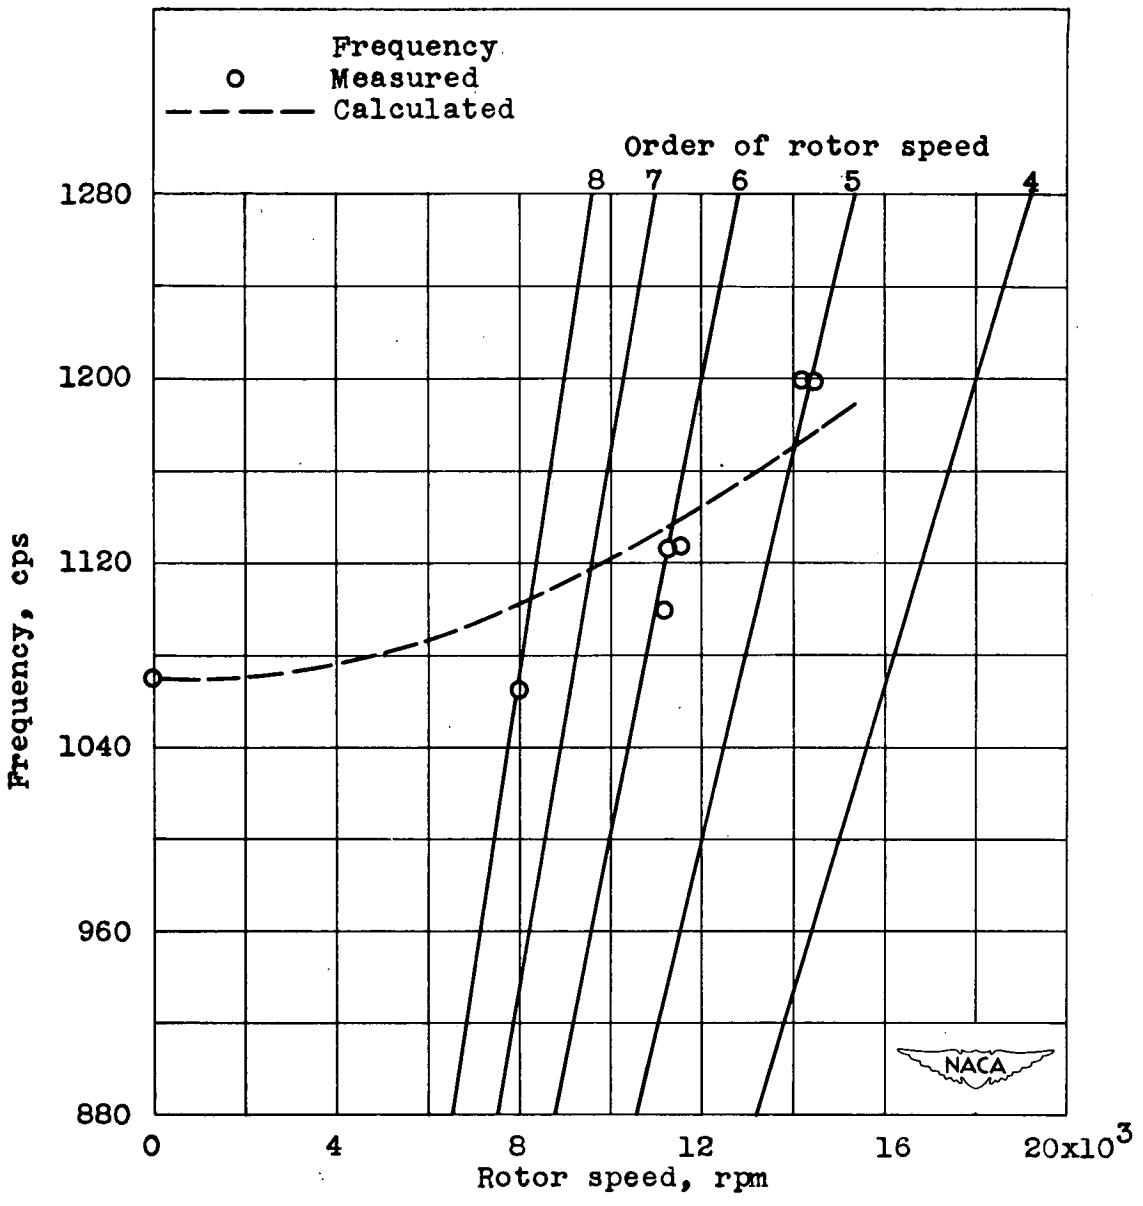
(e) Seventh stage.

The rotor used in this investigation came from one of the first experimental jet units and apparently a tolerance change or a change due to the reblading caused the natural frequencies of the new blades to be higher than those of the original blades. It was found that the average of the natural frequencies of the new blades was 9.8 percent higher than that previously determined in reference 2. This increase in natural frequency and a 4.7-percent average increase in frequency induced by the stiffening effect of the strain-gage installation made it impossible to reach a fourth- and sixth-order resonant condition in the seventh and tenth stages, respectively, without dangerously overspeeding the engine. Artificial reduction of the natural frequencies may permit attainment of these resonances.

Figure 3. - Continued. Critical-speed diagram showing measured and calculated first bending-mode frequencies.

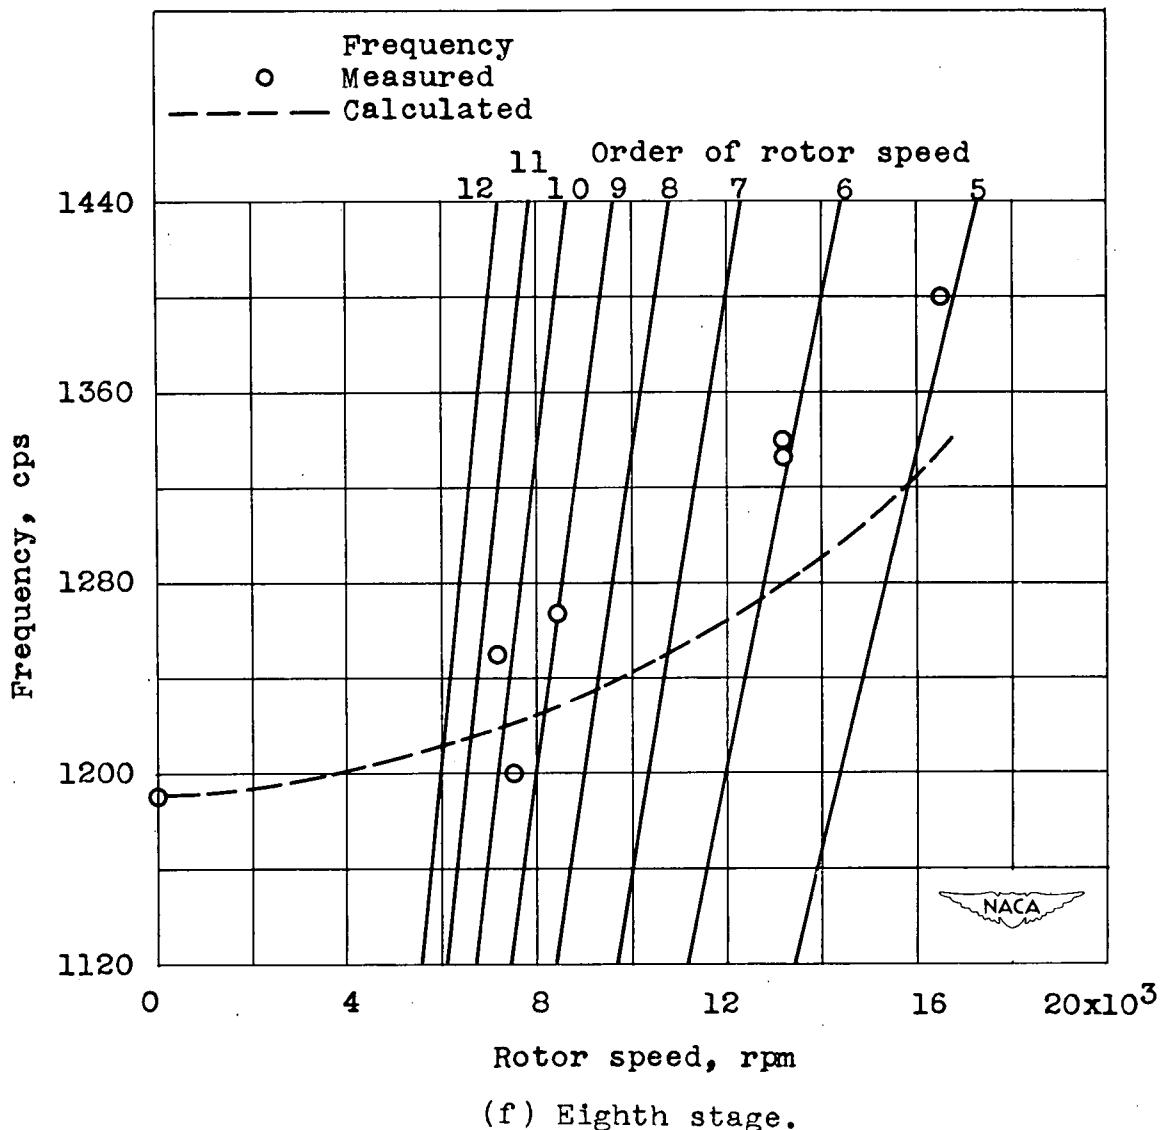
Figure 3. - Continued. Critical-speed diagram showing measured and calculated first bending-mode frequencies.

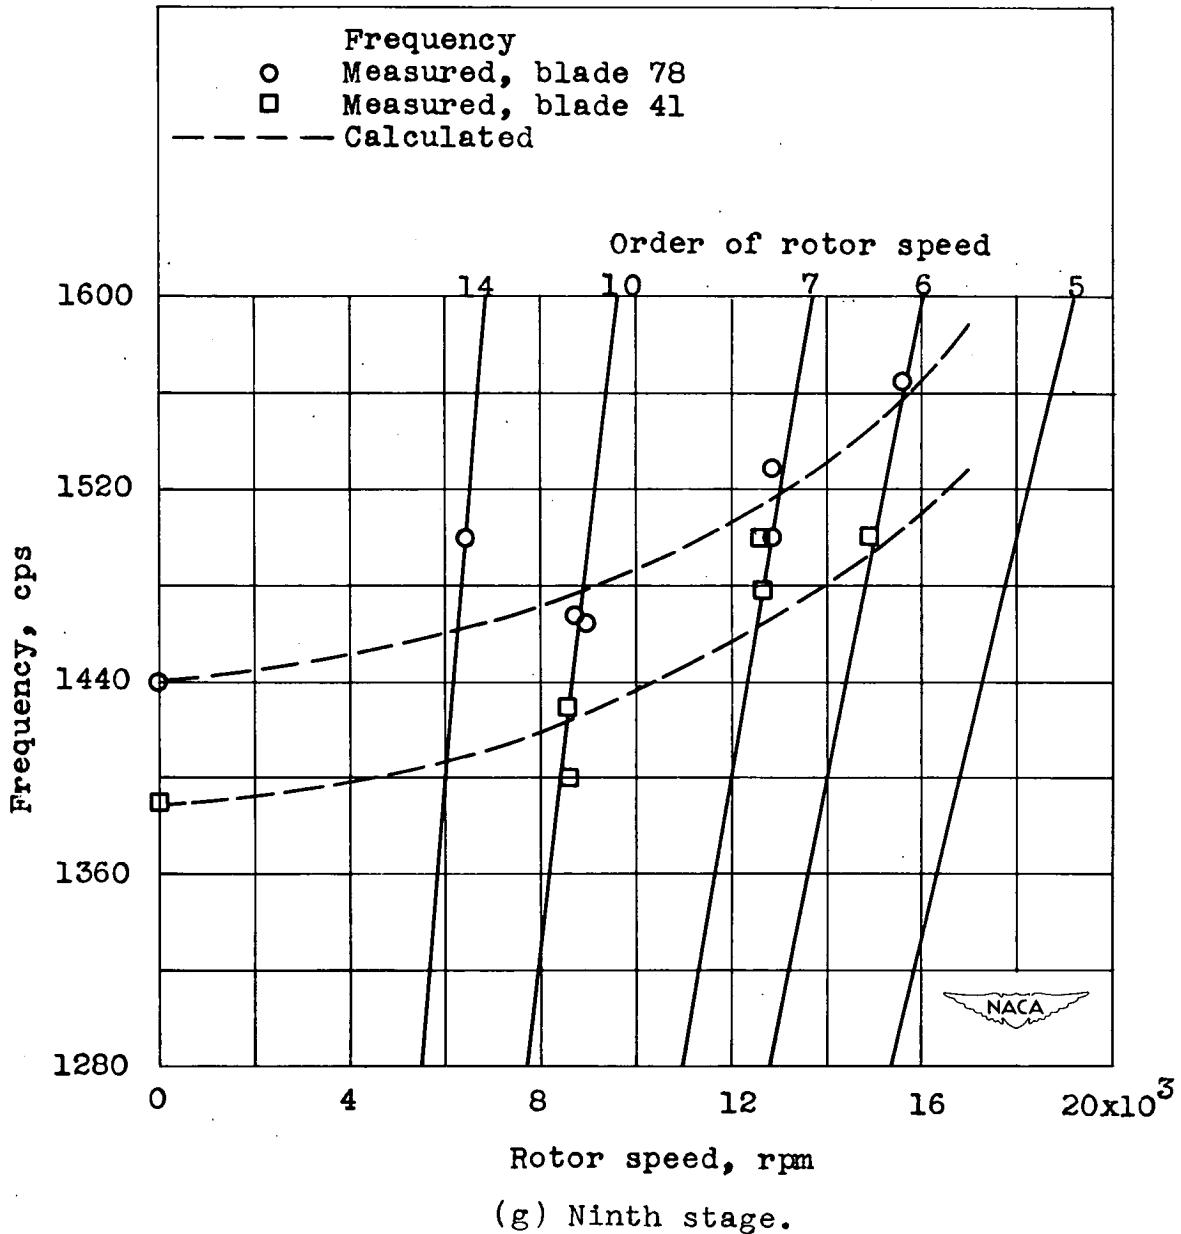
Figure 3. - Continued. Critical-speed diagram showing measured and calculated first bending-mode frequencies.

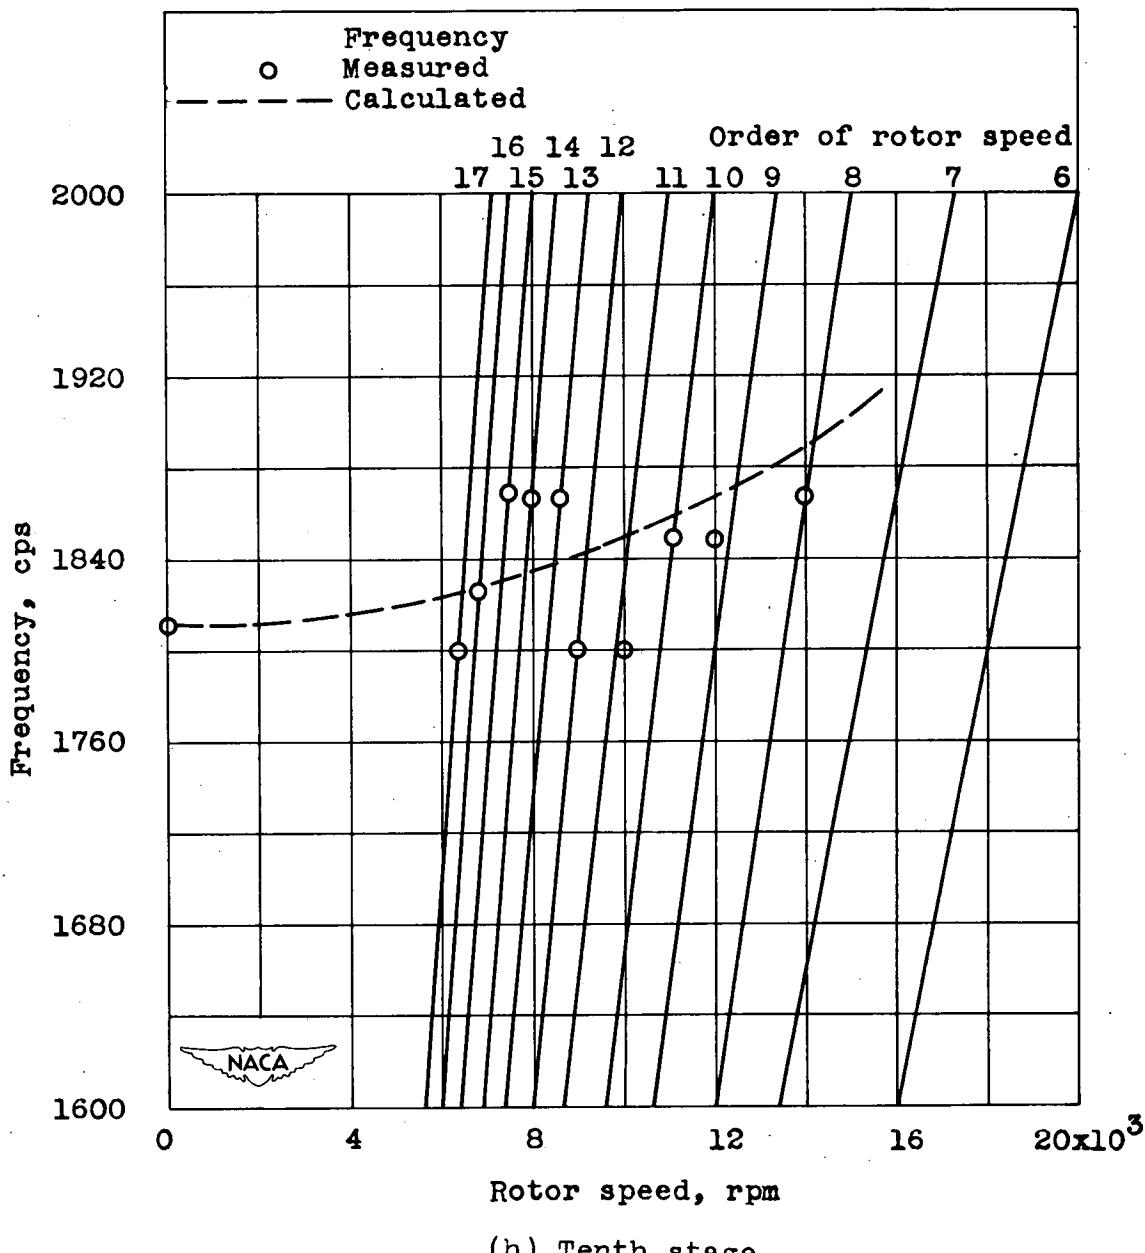
Figure 3. - Concluded. Critical-speed diagram showing measured and calculated first bending-mode frequencies.

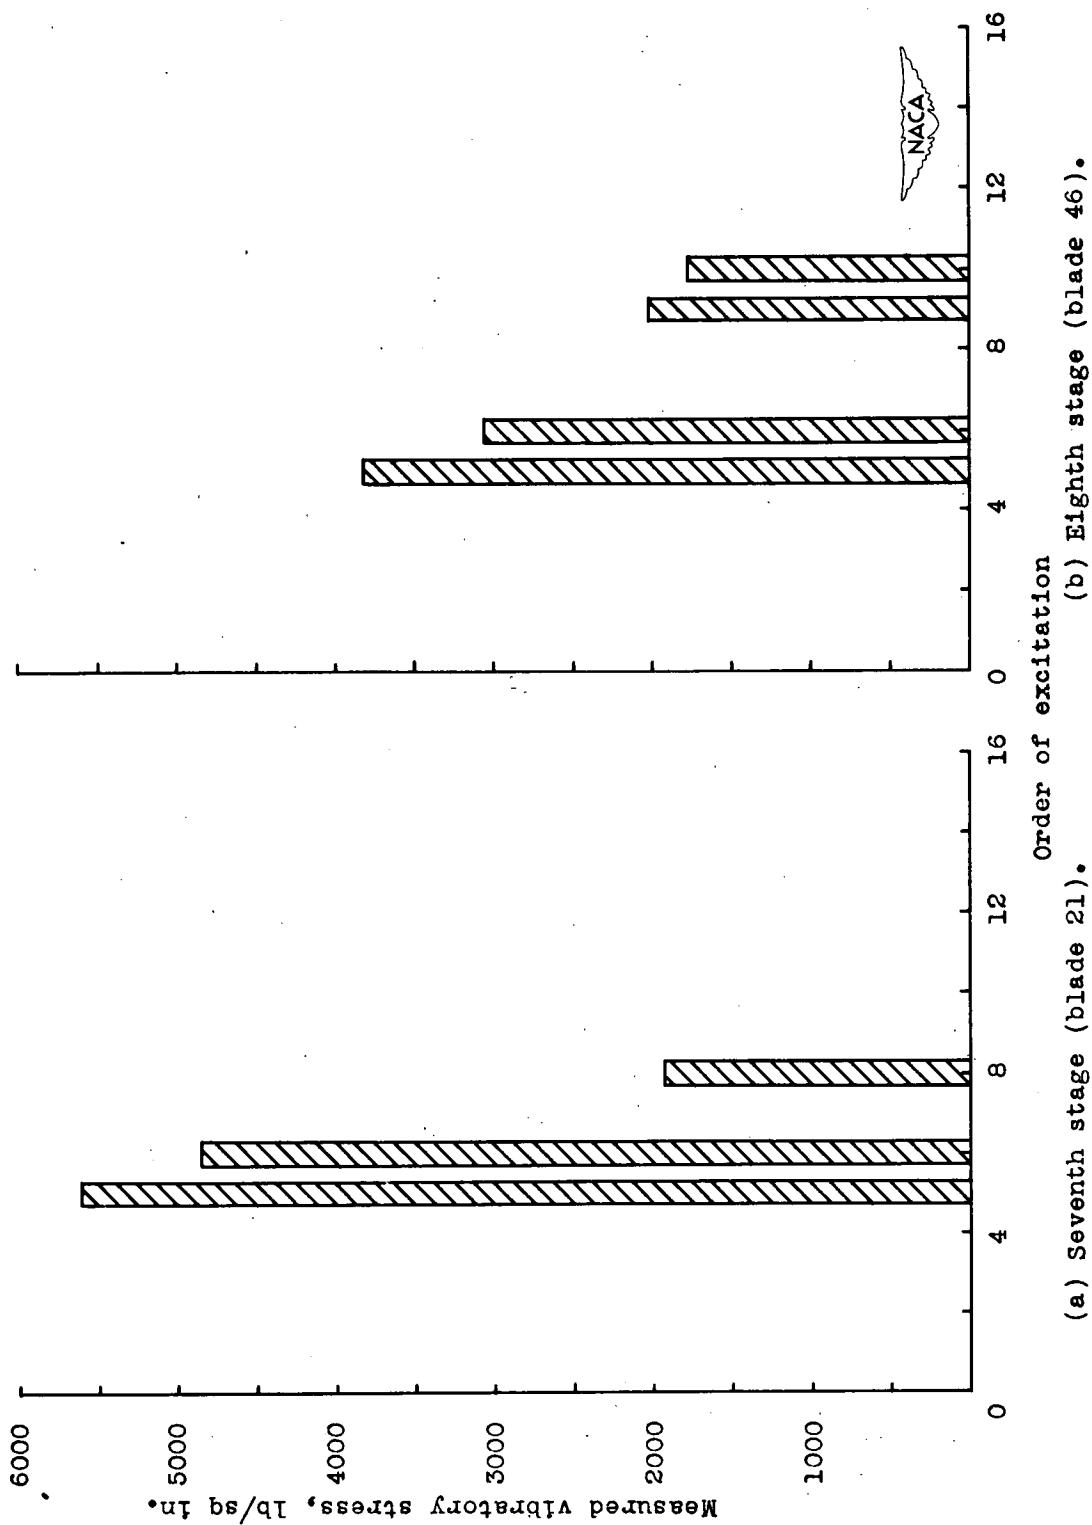
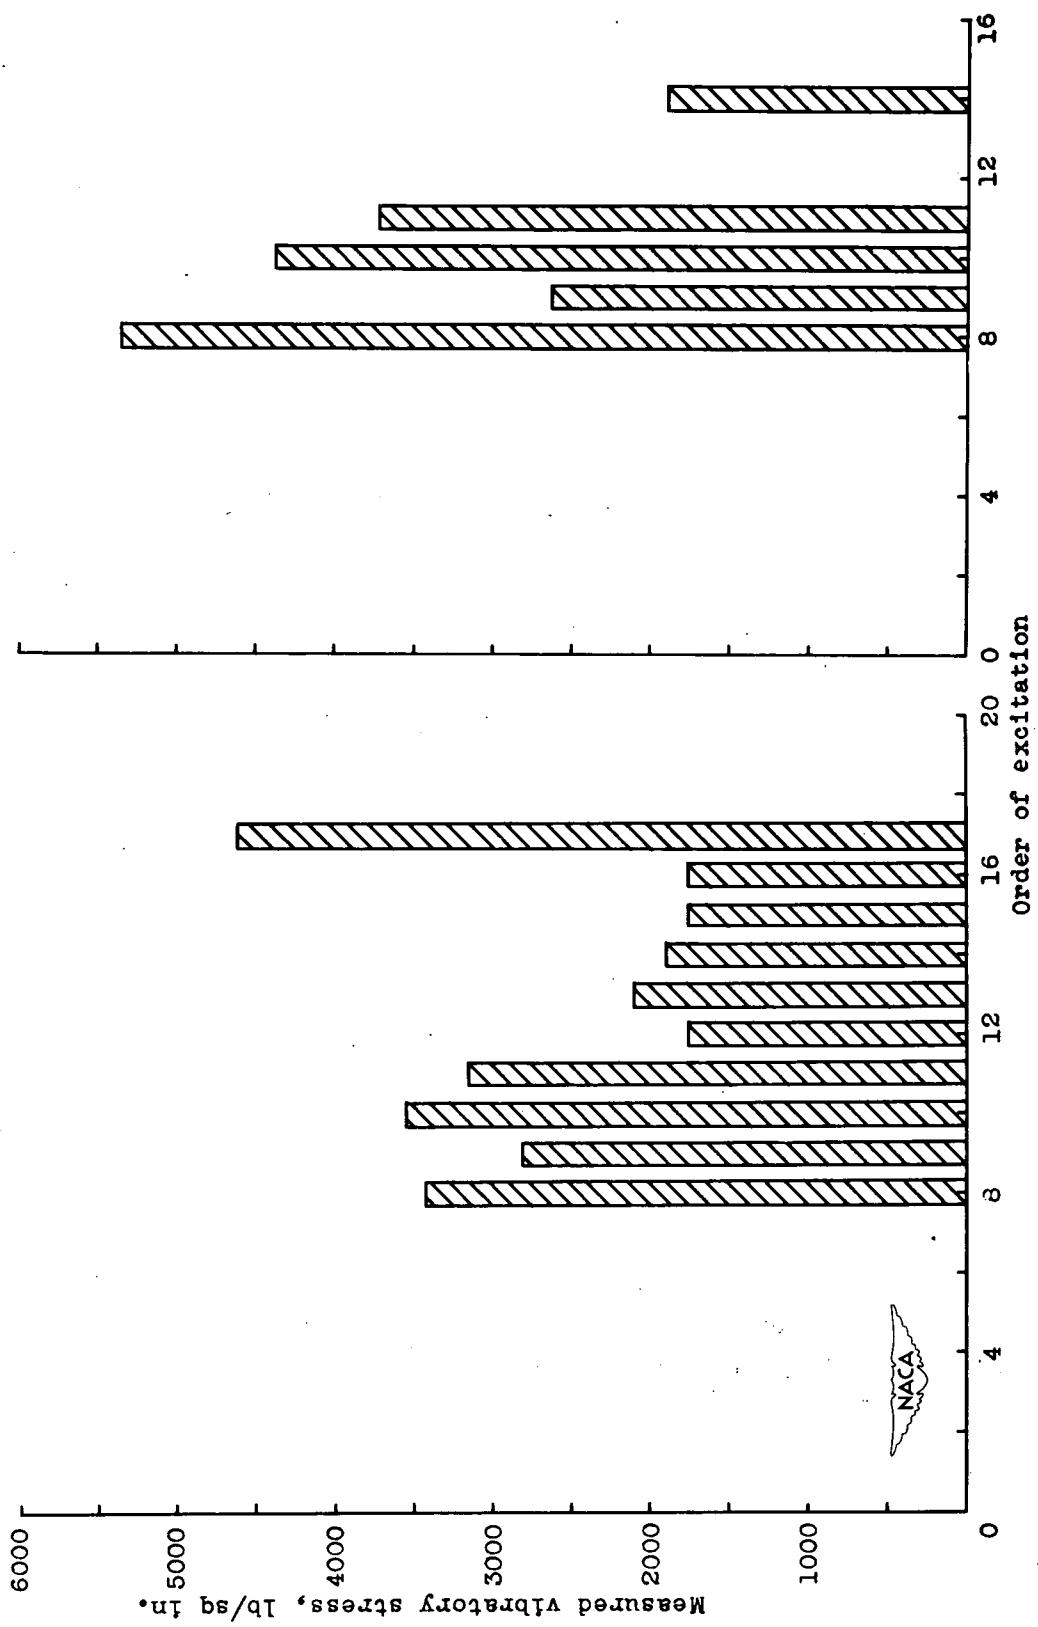
Figure 4. - Relation of magnitude of observed stresses to order of excitation.
 (a) Seventh stage (blade 21). (b) Eighth stage (blade 46).

Figure 4. - Concluded. Relation of magnitude of observed stresses to order number.

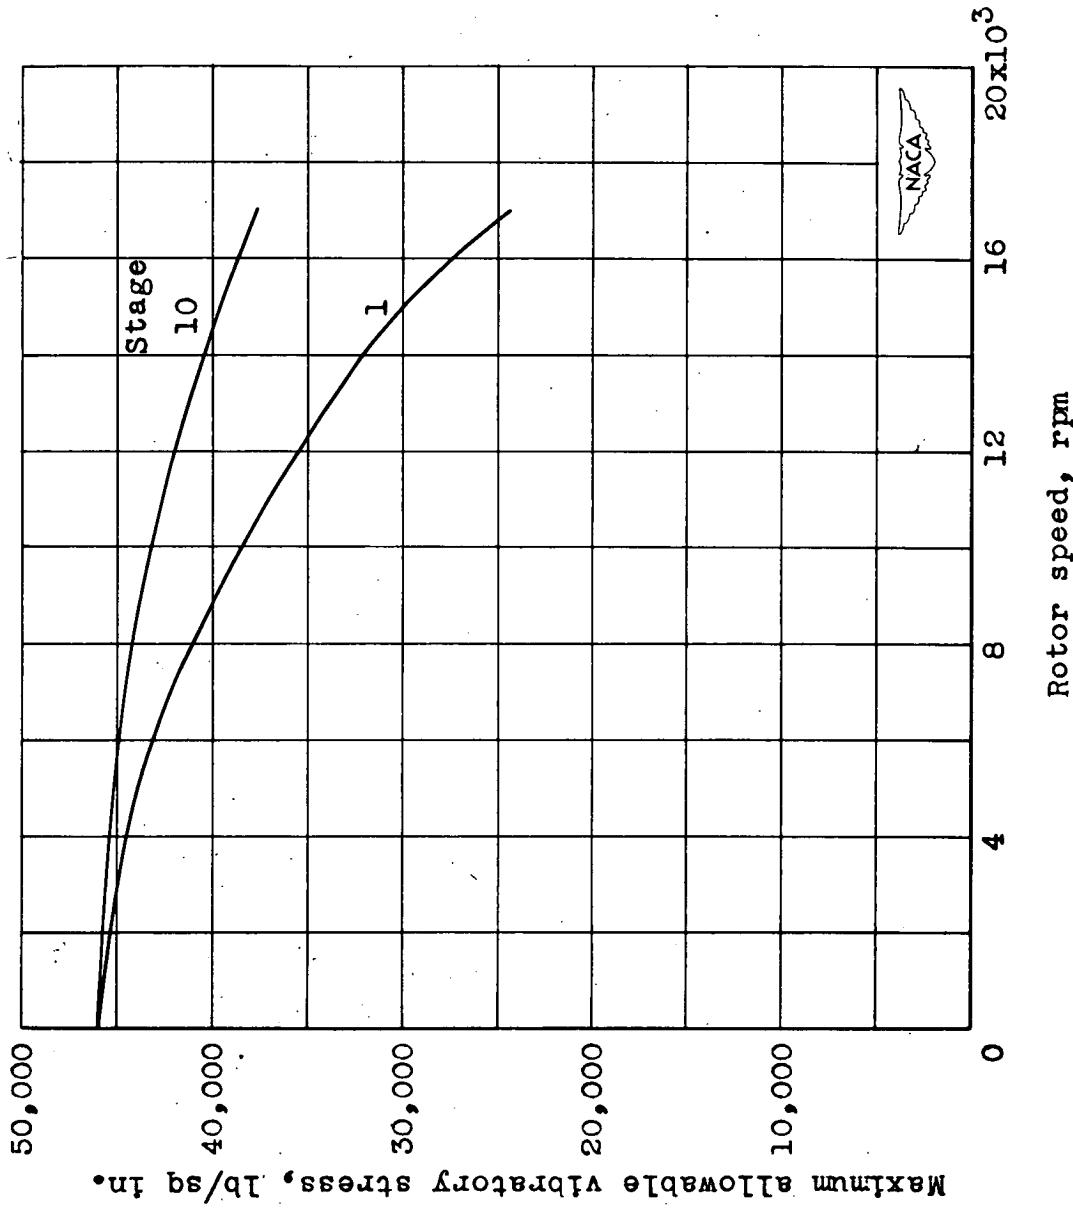
occurred in the third stage and was excited by a fourth-order source. The maximum allowable vibratory stress over the range of rotor speeds is shown in figure 5. Allowable stresses of the intervening stages lie between the curves of the two extreme stages plotted. Data for figure 5 were obtained from calculations of mean working stress (centrifugal stress plus bending stress) and the relation given in reference 3 between mean stress and total allowable stress for the blade material. Vibratory stresses of approximately 35,000 pounds per square inch are necessary to cause failure of the seventh- and tenth-stage blades according to figure 5.

Figure 5. - Variation in maximum allowable vibratory stress with change in rotor speed.

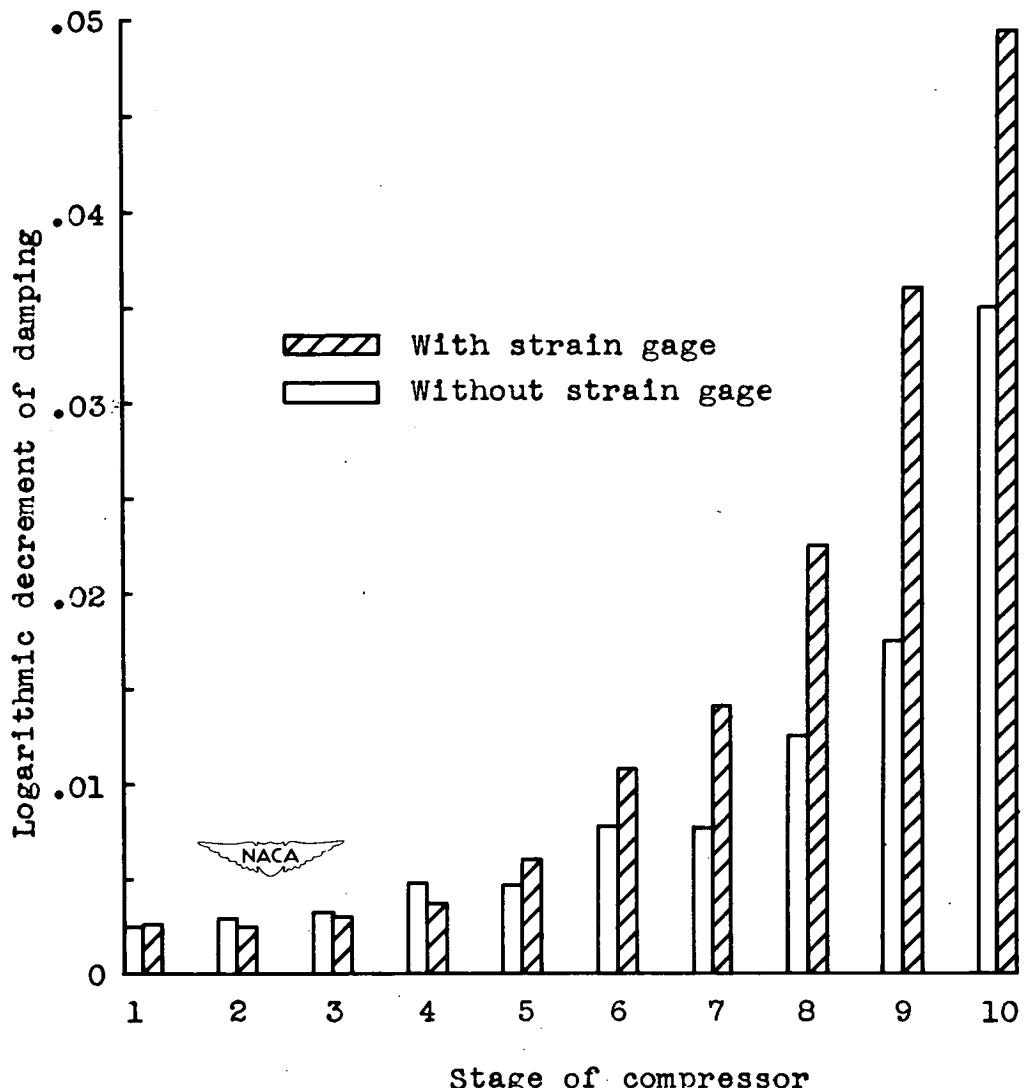
It was suspected that part of the cause for the low measured vibratory stresses might be the additional damping introduced by the presence of the strain gage. The damping values were measured at static conditions for blades with and without gages. In the last five stages, the vibratory stresses might have been reduced by gage installation, as indicated by figure 6; the information is inconclusive, however, because the effect of rotational forces on damping properties is unknown. The inlet guide vanes used also may have lowered the vibrational stresses as well as the compression load, consequently reducing the bending stresses in the rear stages of the compressor. The results of static tests performed to correlate the vibratory-stress magnitudes with the tip amplitudes and with loads of the blades are shown for the seventh and tenth stages in figure 7. Extrapolation of this information indicates that vibrations with tip amplitudes of ± 0.055 and ± 0.084 inch must be attained to cause failure of seventh- and tenth-stage blades, respectively.

Figure 6. - Damping of blades from all stages, with and without strain gages.

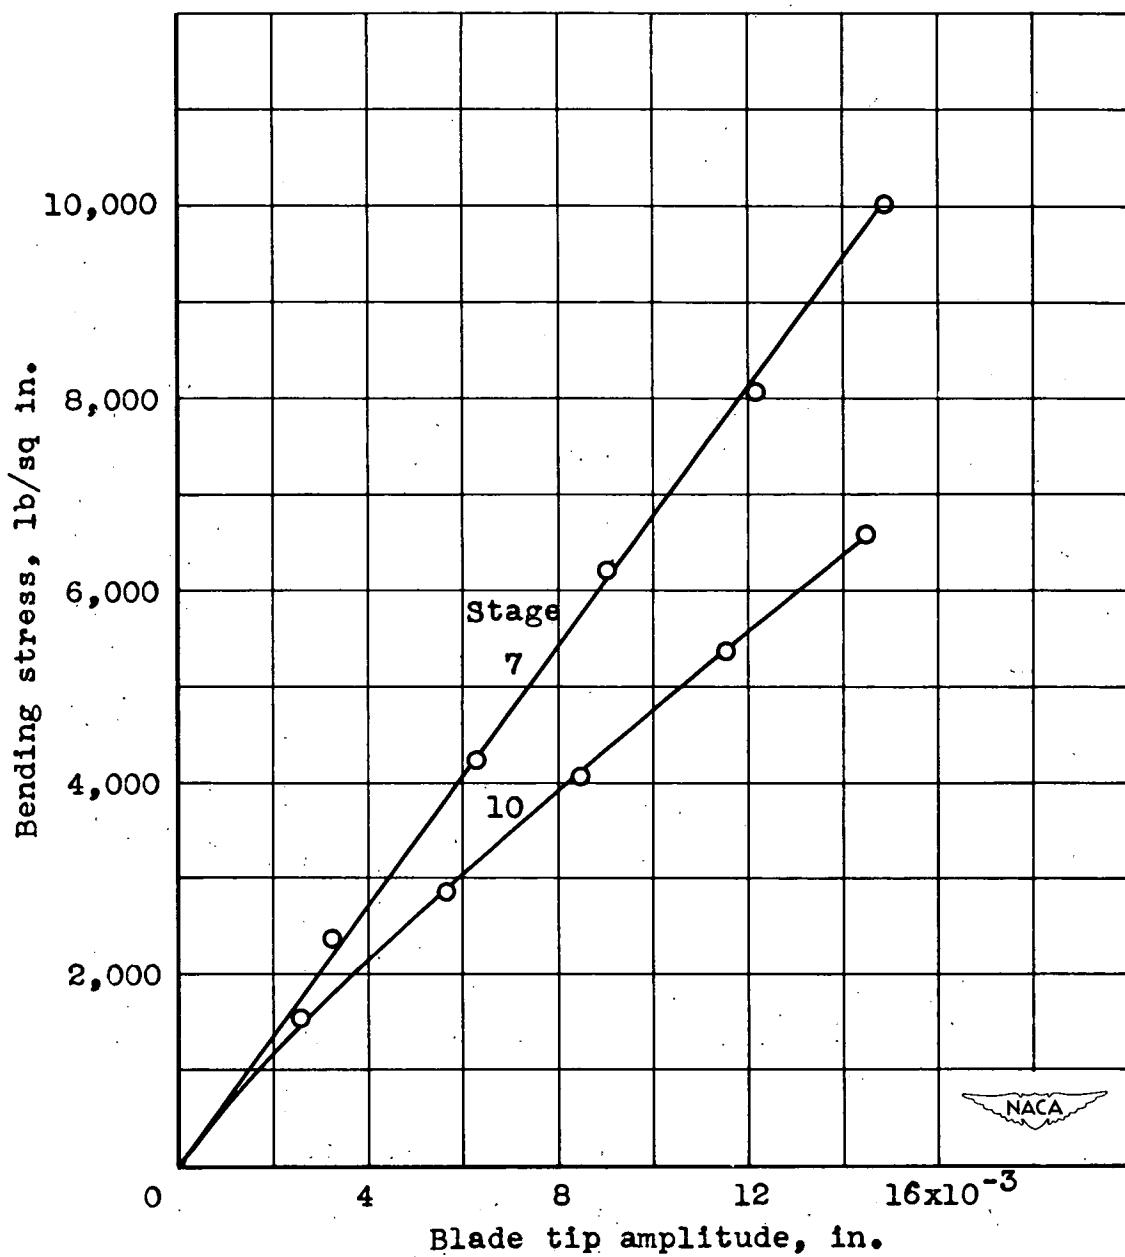
(a) Tip amplitude.

Figure 7. - Static stress for blade tip amplitude and loading.
